FLEX_TES

Design and Construction of the Pit Thermal Energy Storage in Høje Taastrup

The report on the design and construction of the pit thermal energy storage in Høje Taastrup was prepared by PlanEnergi:

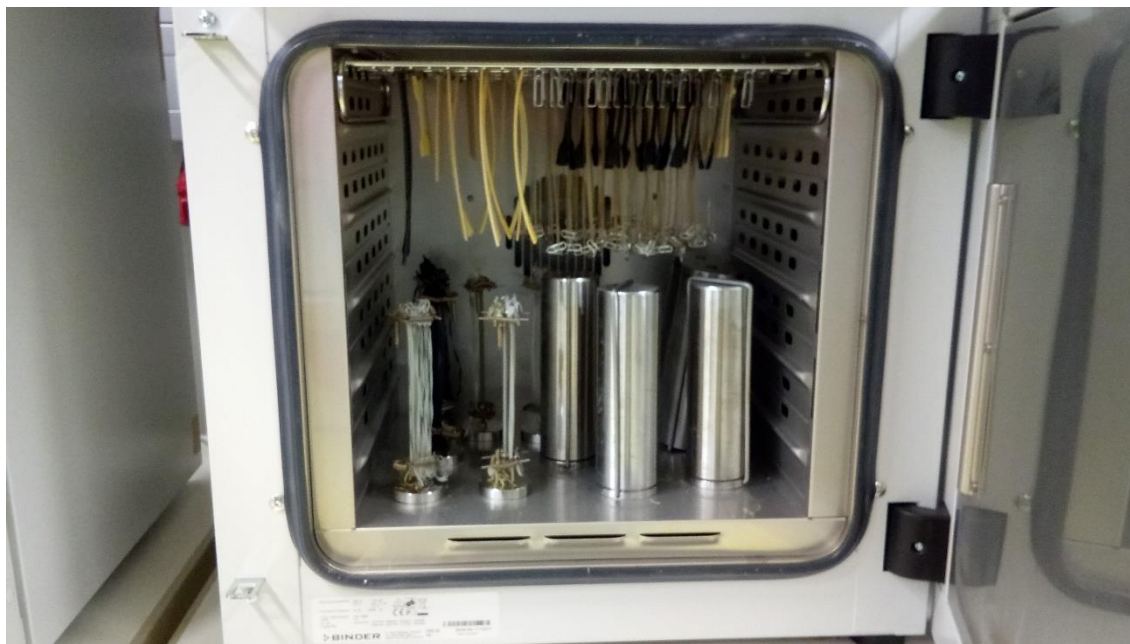
Figure 9: Test oven at the University of Linz.

Professor Gernot Wallner, Institute of Polymeric Materials and Testing, University of Linz, Austria, has for the past 6 years, been working to develop a PP (polypropylene) liner that is better able to withstand high surrounding temperatures. The reason for working with PP rather than HDPE is that PP degrades more slowly in water than HDPE (the opposite is true in air). The development process involves peeling 0.05-0.1 mm strips from a PP sheet. The strips are exposed to high temperatures (humid air being the worst) in a set of ovens. Since polymers degrade faster the thinner they are, results can be obtained relatively quickly. Many tests are performed simultaneously. Figure 9 shows one of the test ovens.

Samples are taken regularly and tested for elongation at break and antioxidant content, among other things.

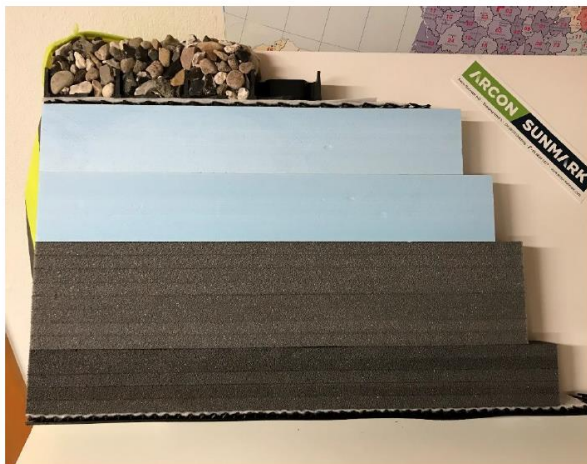
Figure 11: Cross-section of mock-up model of Aalborg CSP's lid construction.

- The lid is modular, built on the same type of liner as proposed in Høje Taastrup.
- Instead of weight pipes, stones are used to weigh down the center of the modules.
- Rainwater is pumped from each module.
- The insulation is replaced with higher density layers (Nomatec) at the bottom and XPS at the top.
- A semi-permeable roofing membrane is used, which allows water vapor to pass through from the low side (as in a roof structure).

The lid design is build up in app. 30 x 30 meters modules

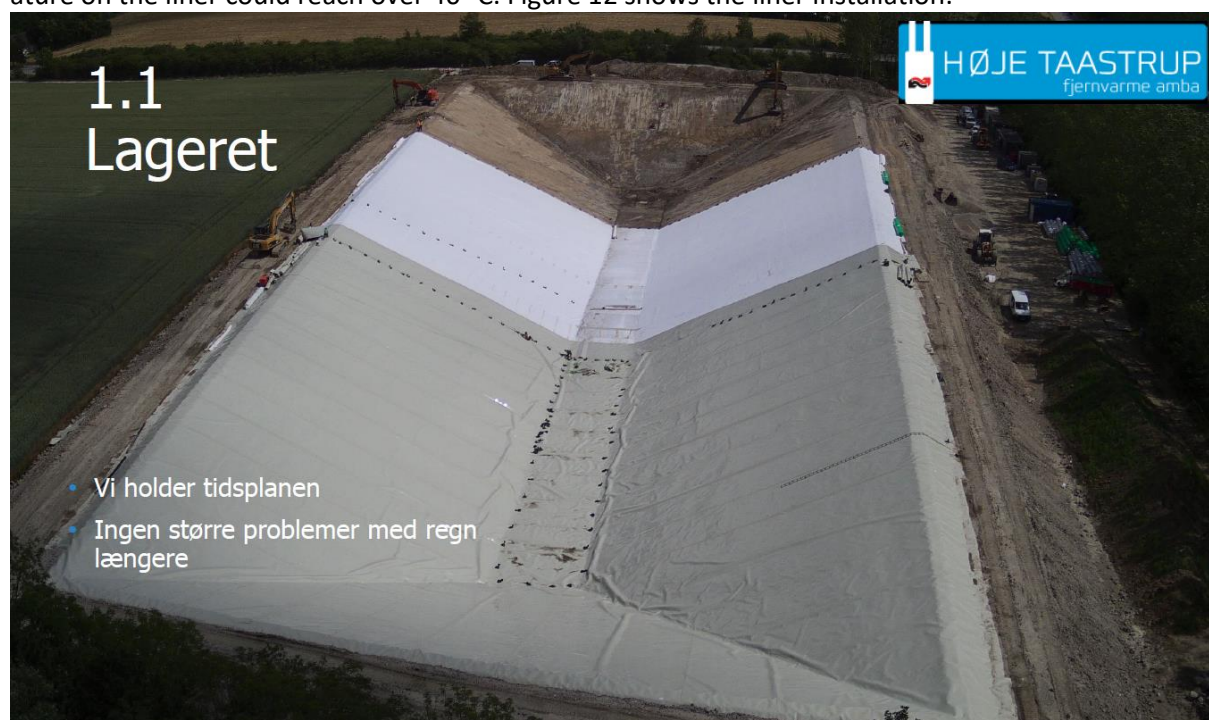
Figure 12: Reporting on the liner work at the steering committee meeting on July 8, 2020.

The installation of the PP membrane went according to plan. It was very hot at times and the temperature on the liner could reach over 40 °C. Figure 12 shows the liner installation:

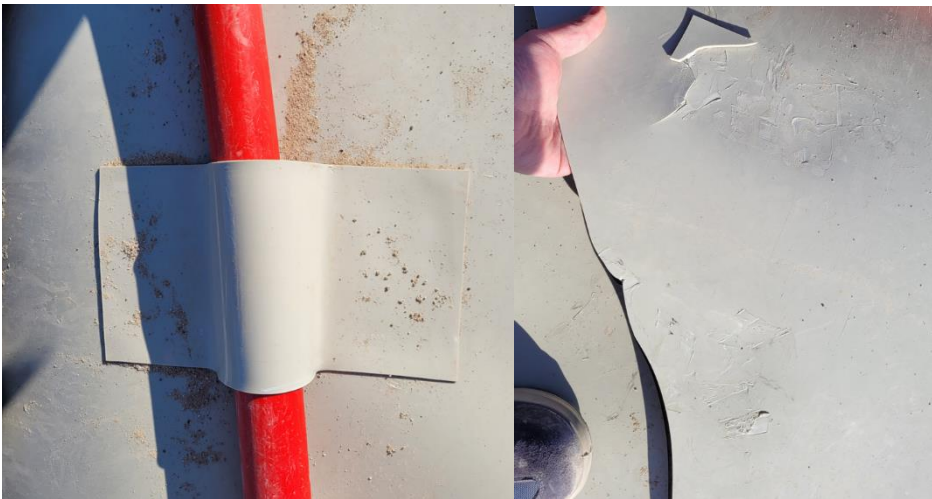
Figure 18: PP strap attached to PP liner and crack in PP liner.

The PP floating liner was to be installed from April 2022. However, during the dismantling of the irrigation system, the PP liner was damaged when a fracture went 60 cm below the water surface. The fracture could be repaired using a "caisson" which kept the water away during the repair.

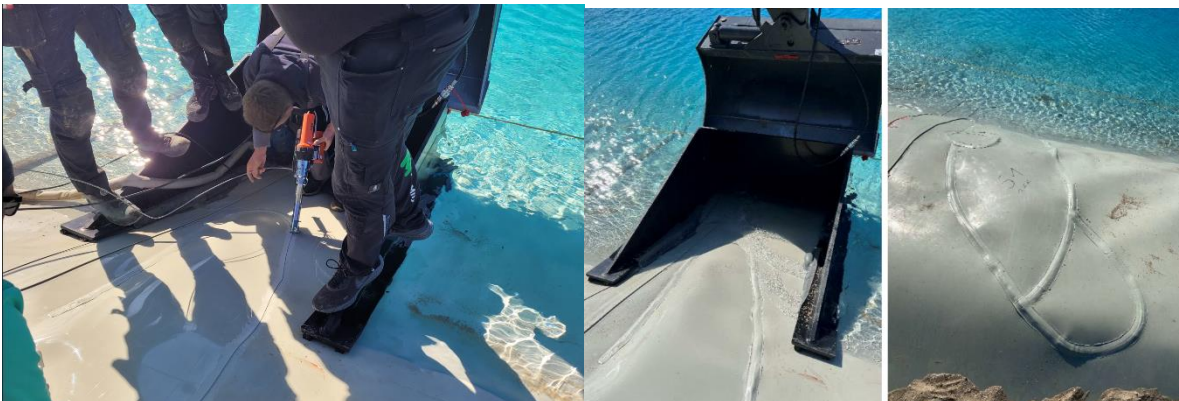
Figure 19: Repairing a crack using a caisson.

For the repair, a caisson was made from plastic sheets. Neoprene seals were attached to the bottom edge of the box. This caisson was lowered from the side edge above the repair site, placed on the PP liner on the slope and subsequently weighted down to press the caisson against the PP membrane. Afterwards, the work area was drained, and the crack was closed with a patch attached with an extruder weld.

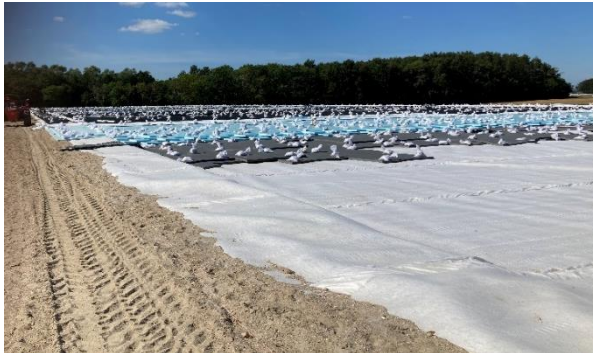
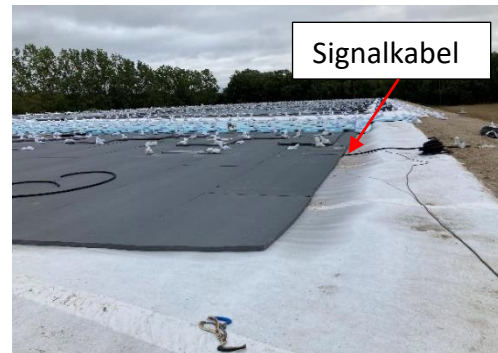
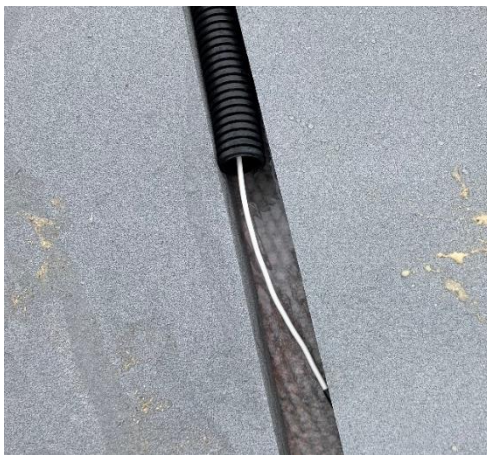
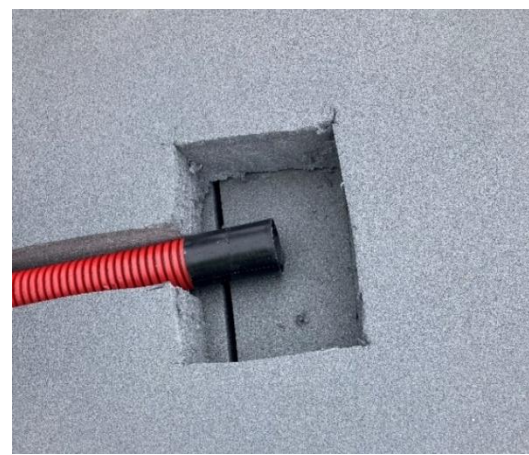
Figure 23: Example of temperature and humidity sensor placement

Building the lid from the eastern end

Placement of the first temperature sensor

PT100 sensor for temperature measurement

Cut-out in insulation for Hygro-Smart humidity sensor HS3

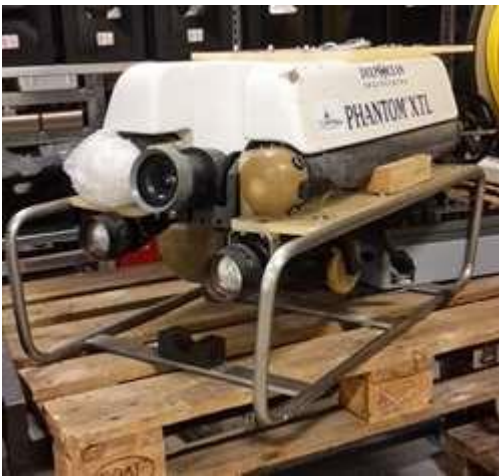
Figure 25: Phantom XTL underwater drone

Temperature measurements showed that the bottom of the storage was around 50°C at the time of the inspection. It was possible to see that the liner surface was smooth and that no noticeable creases had appeared as a result of the temperature increase compared to the time of installation.

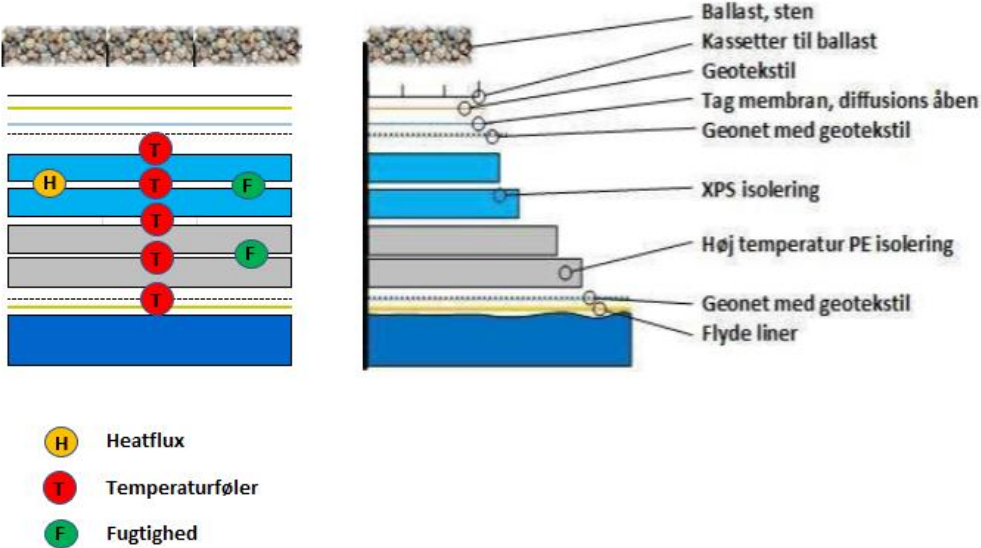
<p>Ballast, sten Kassetter til ballast Geotekstil Tag membran, diffusions åben Geonet med geotekstil XPS isolering Høj temperatur PE isolering Geonet med geotekstil Flyde liner</p> <p>H Heatflux T Temperaturføler F Fugtighed</p>	<p>Not relevant until the system is in normal operation.</p> <p>The heat flux can be recorded after connecting measuring equipment.</p> <p>Calculations can be performed after connecting temperature sensors.</p> <p>Early 2023</p>
15	DRONE FLYOVER FOR THERMOGRAPHY	Client

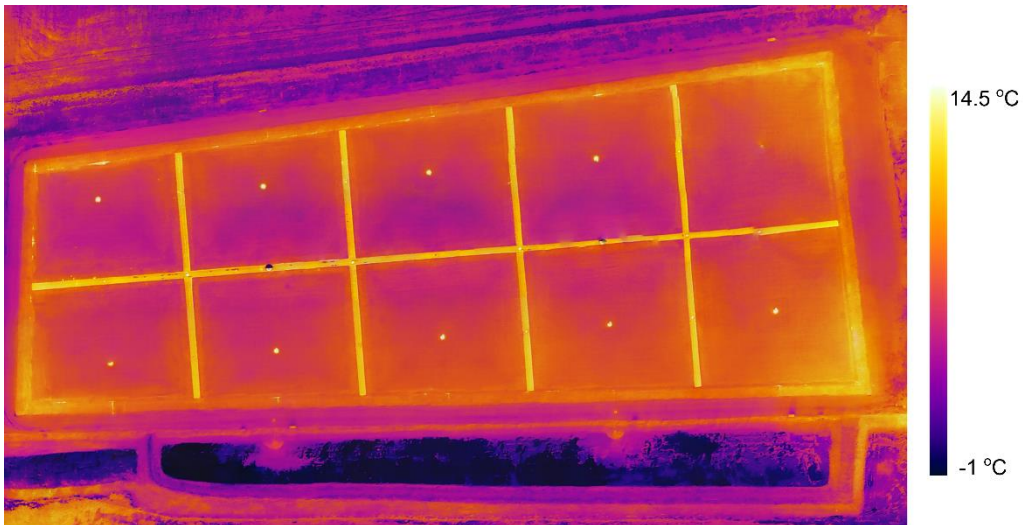
<p>14.5 °C -1 °C</p>	<p>Drone flyover</p> <p>Thermographic control of thermal bridges. The image is from a morning with sunrise in the east, which has caused higher surface temperatures at the eastern end.</p> <p>Early 2023</p>
